**TRANSMISSION POLES WITH SUB-STANDARD CREOSOTE RETENTIONS  
PROTECTED BY FIELD LINERS OUTPERFORM STANDARD POLES IN SERVICE**

**Mr. Michael R. Behr\*, Dr. Graham D. Shelver\* and Prof. Albin A.W. Baecker\*\***

**Paper prepared for the 28th Annual Meeting  
Whistler, Canada  
24-30 May 1997**

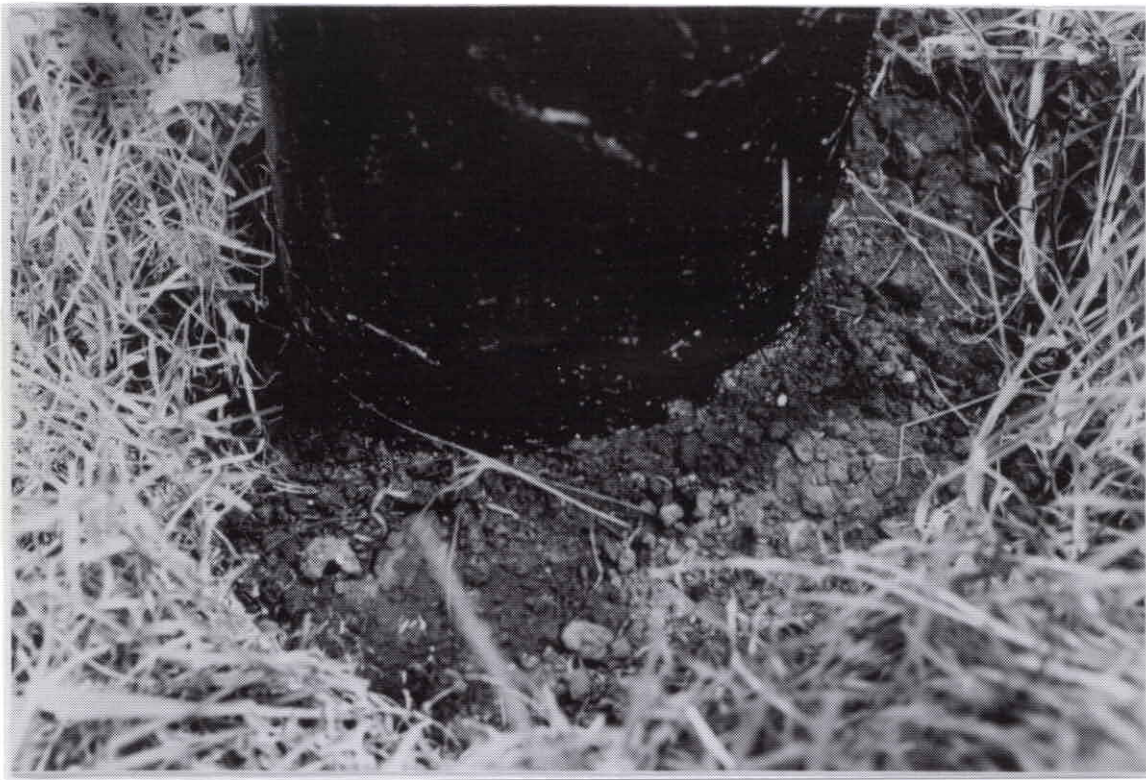
Fig. 1. Ground line of standard transmission pole (treated with  $100\text{kg.m}^{-3}$  creosote by the full cell process) after 12 months' service . Bleeding creosote is visible running down the surface of the pole and the soil surrounding the pole is visibly polluted with the leached creosote. Note lack of vegetation in bare polluted zone of poisoned soil.

**Assessment.** The poles with and without Field Liners were inspected after 12 months service. It was found that the full specification poles without Field Liners had leached creosote which was visible in the surrounding soil (Fig. 1), and which had inhibited growth of vegetation around the poles. In marked contrast, the poles with Field Liners were surrounded with plant growth and no creosote could be detected in the soil around these poles.

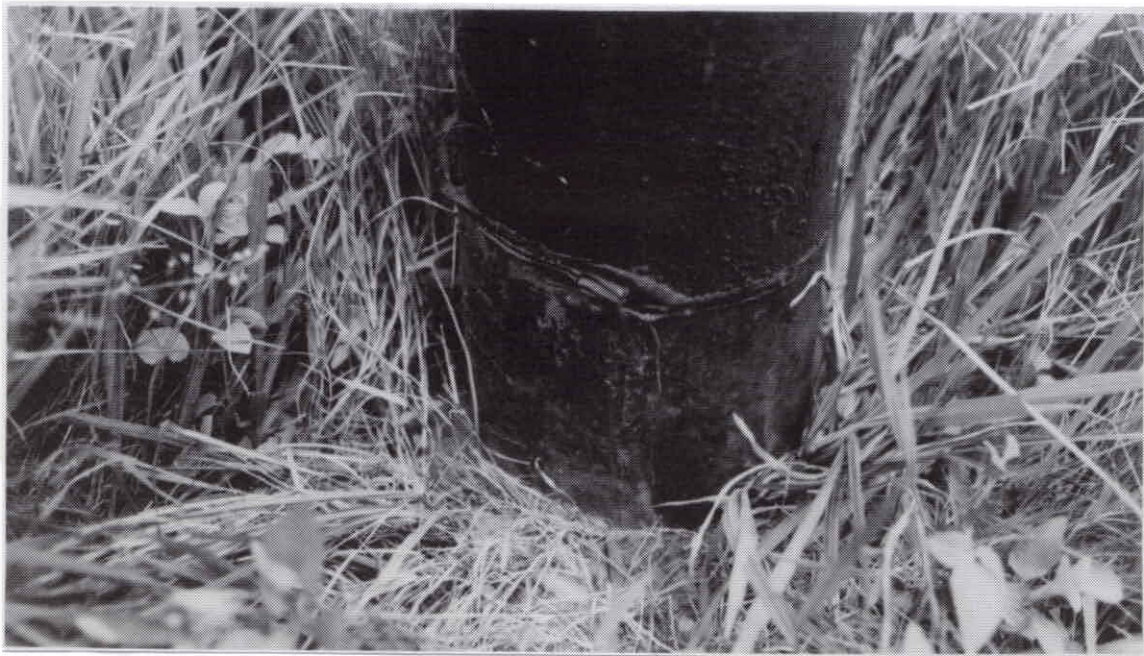
Fig. 2. Ground line of sub-standard transmission pole (treated with  $80\text{kg.m}^{-3}$  creosote by the full cell process) after 12 months' service. No creosote was visible running down the sides of such poles, nor was the soil surrounding them polluted by creosote. In keeping with these observations, no bare soil existed and vegetation completely surrounded the poles.

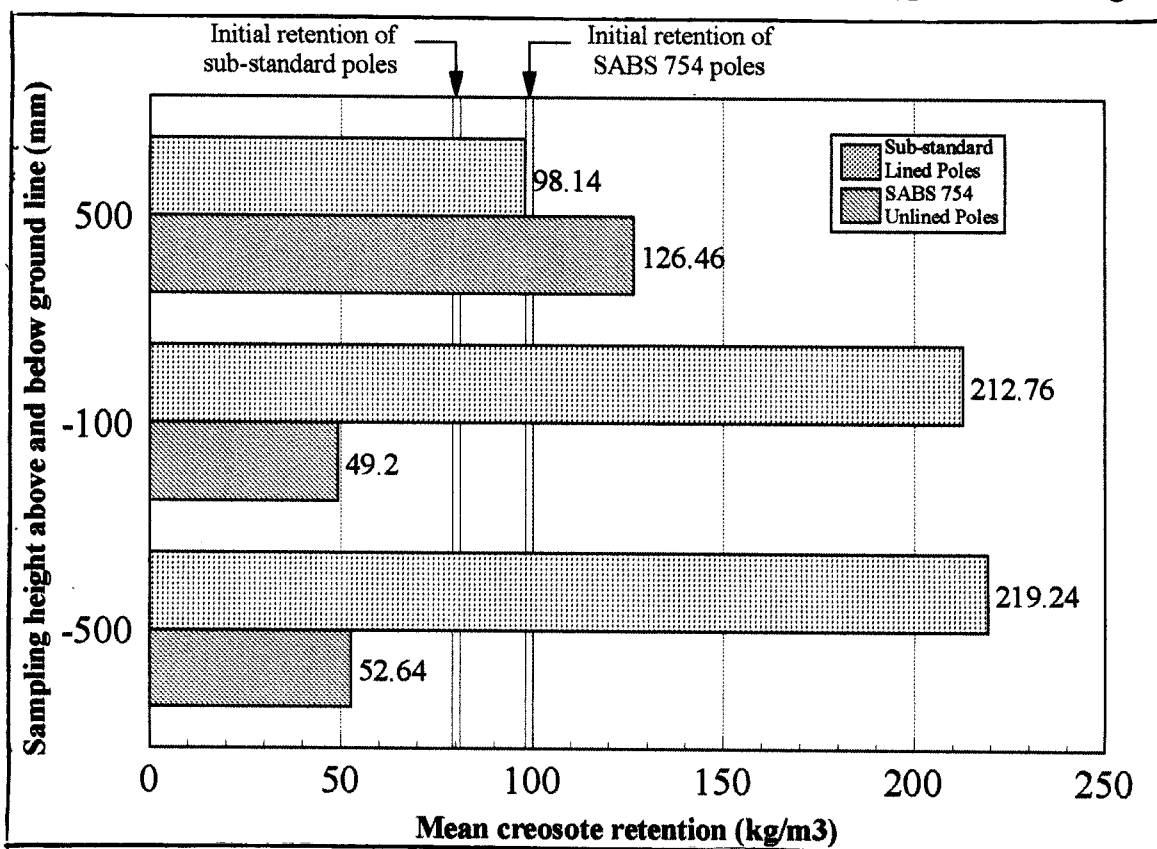
Fig. 3. Mean creosote retentions in profiles of sub-standard transmission poles with Field Liners and standard poles without Field Liners after 12 months' service in ground contact.

It is worthy of note that, when windows were cut to take samples from below the groundlines of the sub-standard poles with Field Liners, a thin layer of creosote found between the wood surface and the interior of the Field Liner in each case marked the hands of the authors. In contrast, the equivalent surfaces of standard poles without Field Liners did not leave creosote deposits on the hands of the authors, presumably because it was already in the soil (c.f. , Fig. 1). The creosote analyses of core samples was converted to retentions as listed in Table 1. and the mean values of these retentions are illustrated in Fig. 3.

Table 1. Creosote contents\* of sub-standard transmission poles with Field Liners and standard poles without Field Liners after 12 months' service with verified creosote retentions of 80kg.m<sup>-3</sup> while the standard poles began with verified retentions of 100kg.m<sup>-3</sup>

Position of core in pole	Sub-standard Pole with Field Liner			Standard Pole without Field Liner		
	1	2	3	4	5	6
500mm below ground line	15.26 (91.56)	16.66 (99.96)	17.15 (102.90)	23.04 (138.24)	23.66 (141.96)	16.53 (99.18)
	(mean = 98.14)			(mean = 126.46)		
100mm below ground line	27.96 (167.76)	36.91 (221.46)	41.51 (249.06)	14.17 (85.02)	6.88 (41.28)	3.55 (21.30)
	(mean = 212.76)			(mean = 49.20)		
500mm above ground line	26.60 (159.60)	42.44 (254.48)	40.58 (243.48)	15.79 (94.74)	8.40 (50.40)	2.13 (12.78)
	(mean = 219.24)			(mean = 52.64)
